# TECHNICAL INFORMATION

## US61 Varnish gelled

<b>Release Date</b>	May 28, 2025	<b>Bulletin No</b>	TB0181c
<b>Important</b>	<input checked="" type="checkbox"/>	<b>Maintenance parts</b>	<input type="checkbox"/>
<b>Preventive Action report No</b>	-		
<b>Model</b>	US61-Va (XPJ-1462UF, XPJ-1682UR)

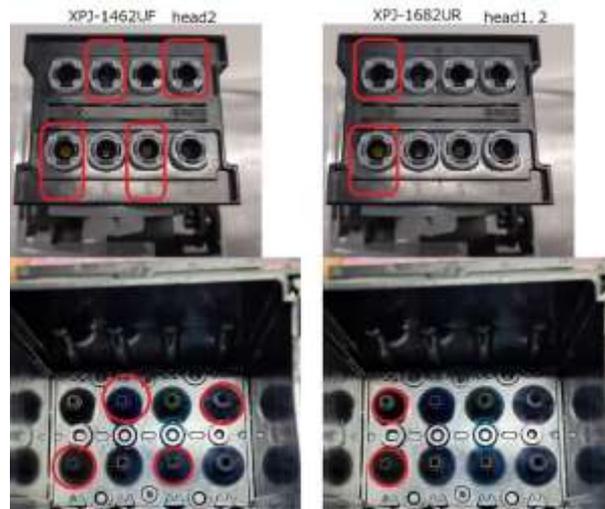
Use a dropper to fill it with maintenance cleaner until the cleaner almost overflows the cap.

Cap Out.

->Cleaner inside the cap assembly.

\*Fill the cleaner up to the edge of the cap.
